**DEPARTMENT OF TRANSPORTATION**

Contract #: 04-0120F4Cty: SF/ALA Rte: 80 PM: 13.2/13.9File #: 69.28**WELDING INSPECTION REPORT****Resident Engineer:**Siegenthaler, Peter**Address:** 333 Burma Road**City:** Oakland, CA 94607**Report No:** WIR-018858**Date Inspected:** 25-Dec-2010**Project Name:** SAS Superstructure**OSM Arrival Time:** 700**Prime Contractor:** American Bridge/Fluor Enterprises, a JV**OSM Departure Time:** 1900**Contractor:** Zhenhua Port Machinery Company, Ltd (ZPMC), Changxing Island **Location:** Shanghai, China**CWI Name:** An Qing Xiang**CWI Present:** Yes No**Inspected CWI report:** Yes No N/A**Rod Oven in Use:** Yes No N/A**Electrode to specification:** Yes No N/A**Weld Procedures Followed:** Yes No N/A**Qualified Welders:** Yes No N/A**Verified Joint Fit-up:** Yes No N/A**Approved Drawings:** Yes No N/A**Approved WPS:** Yes No N/A**Delayed / Cancelled:** Yes No N/A**Bridge No:** 34-0006**Component:** Orthotropic Box Girder( OBG)**Summary of Items Observed:**

OBG # TRIAL ASSEMBLY YARD

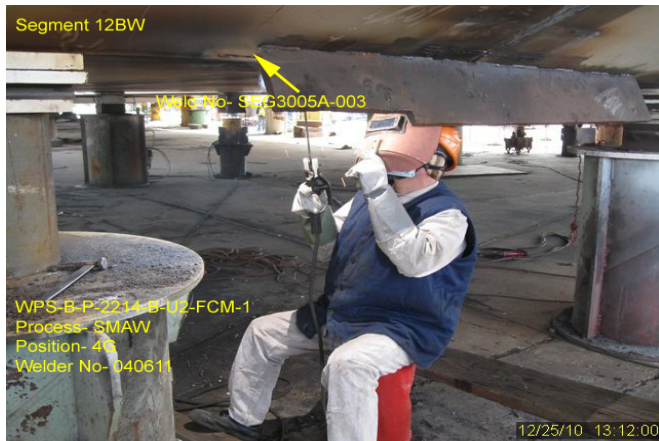
**WELDING:****Segment 12BW**

This QA Inspector observed ZPMC qualified welding personnel identified as 040611 perform Shielded Metal Arc Welding (SMAW), weld joint identified as SEG3005A-003; located On Orthotropic Box Girder (OBG) Bottom Plate to Side Plate CJP Weld; ZPMC Quality Control (QC) is identified as Mr. Zhou Peng. The welding variables recorded by QC appeared to comply with applicable WPS-B-P-2214-B-U2-FCM-1. See attached photo for further details.

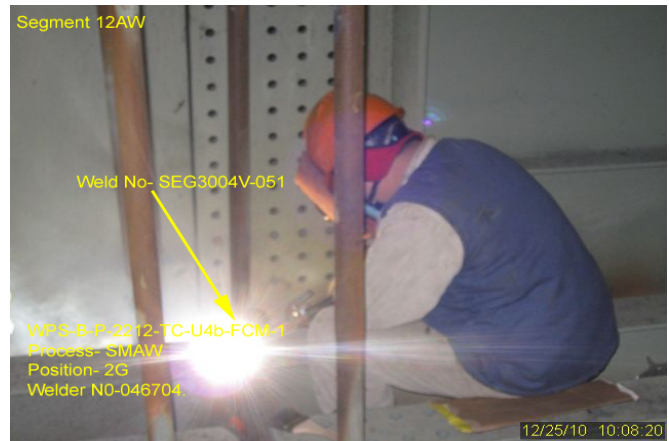
**Segment 12AW**

This QA Inspector observed ZPMC qualified welding personnel identified as 046704 perform Shielded Metal Arc Welding (SMAW), weld joint identified as SEG3004V-051; located On Orthotropic Box Girder (OBG) Bottom

Plate to Longitudinal Diaphragm CJP Weld; ZPMC Quality Control (QC) is identified as Mr. Zhou Peng. The welding variables recorded by QC appeared to comply with applicable WPS-B-P-2212-TC-U4b-FCM-1. See attached photo for further details.
